**DANCE HALL FIRE
GOTHENBURG, SWEDEN
OCTOBER 28, 1998**

**FIRE
INVESTIGATIONS**

Dance Hall Fire

Gothenburg, Sweden
October 28, 1998

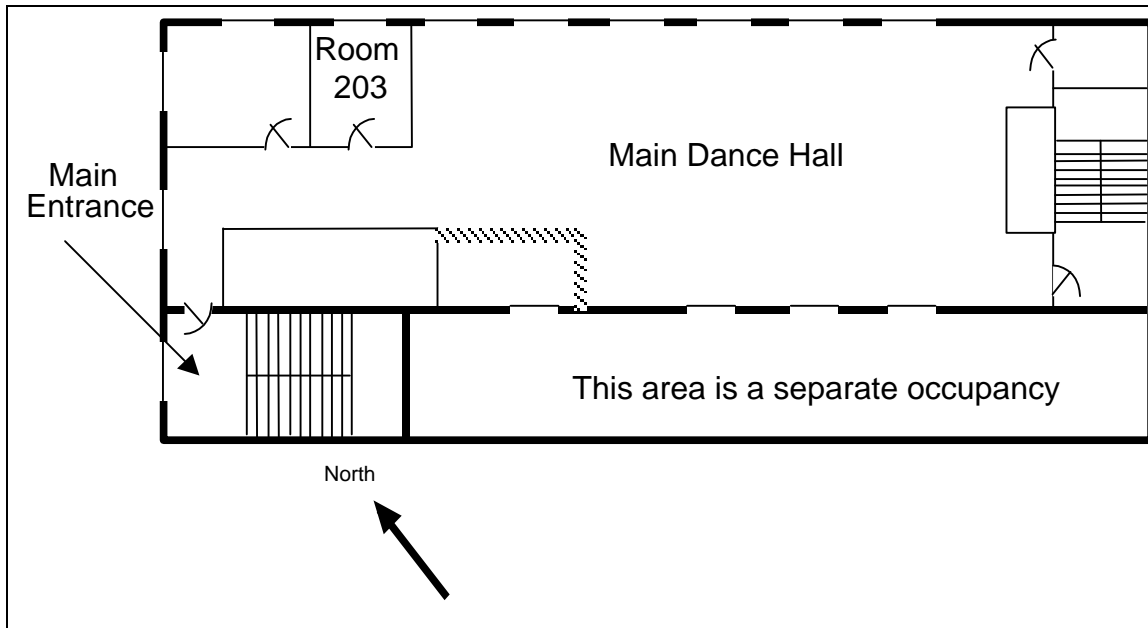
Figure No. 1 – Site Plan

A kitchen area was located in the southwest corner of the hall. There were a number of rooms located at the northwest end of the hall. (See Figure No. 1)

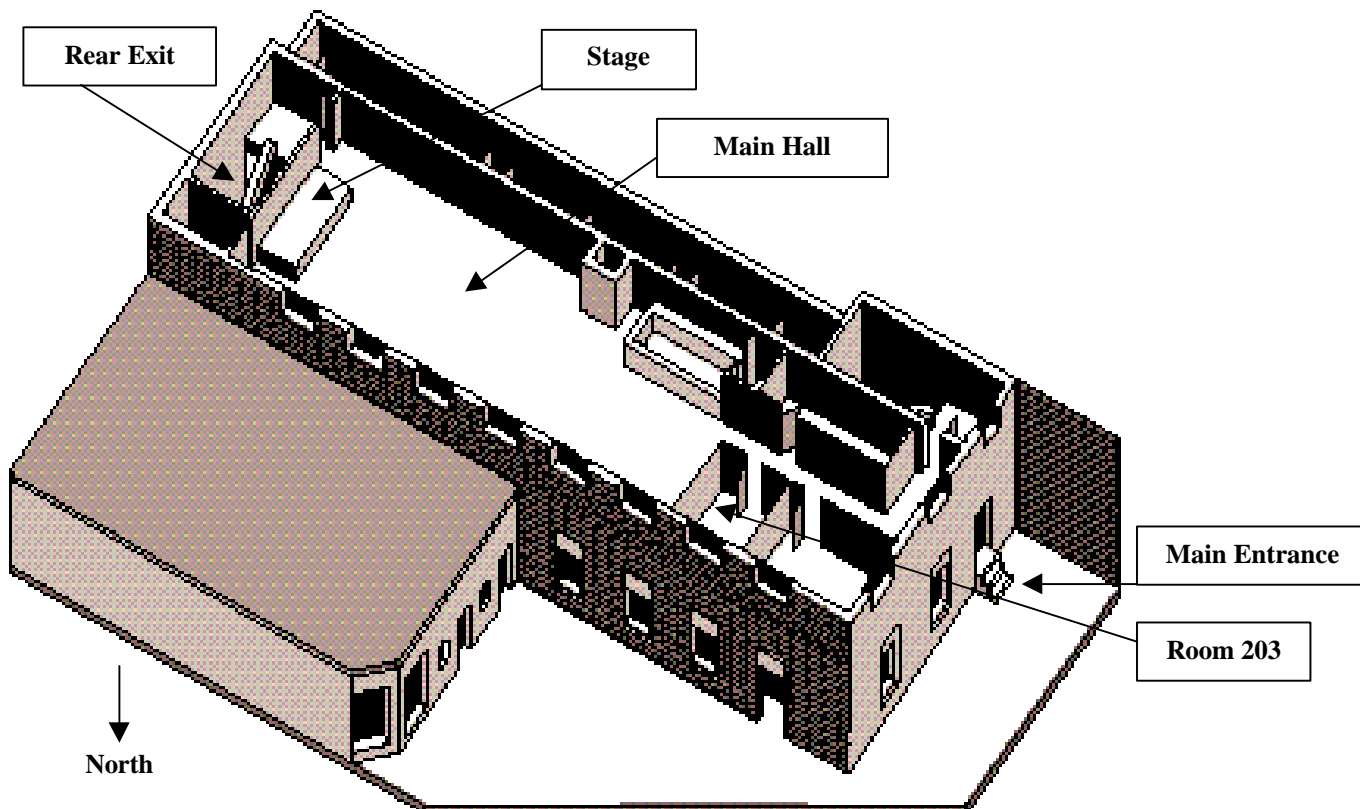
Figure No. 2 – Detailed Site Plan

One room, referred to on the plans as room #203, measured 3.4 m by 4 m (11 ft by 13 ft). Another room, referred to as room #202, measured 5.2 m by 4 m (17 ft by 13 ft). Both of these rooms were equipped with hollow-core doors that swung into the rooms. Room #203 had one exterior window on the northeast wall, and room #202 had two exterior walls, one on the northeast wall and one on the northwest wall. (See Figure 2)

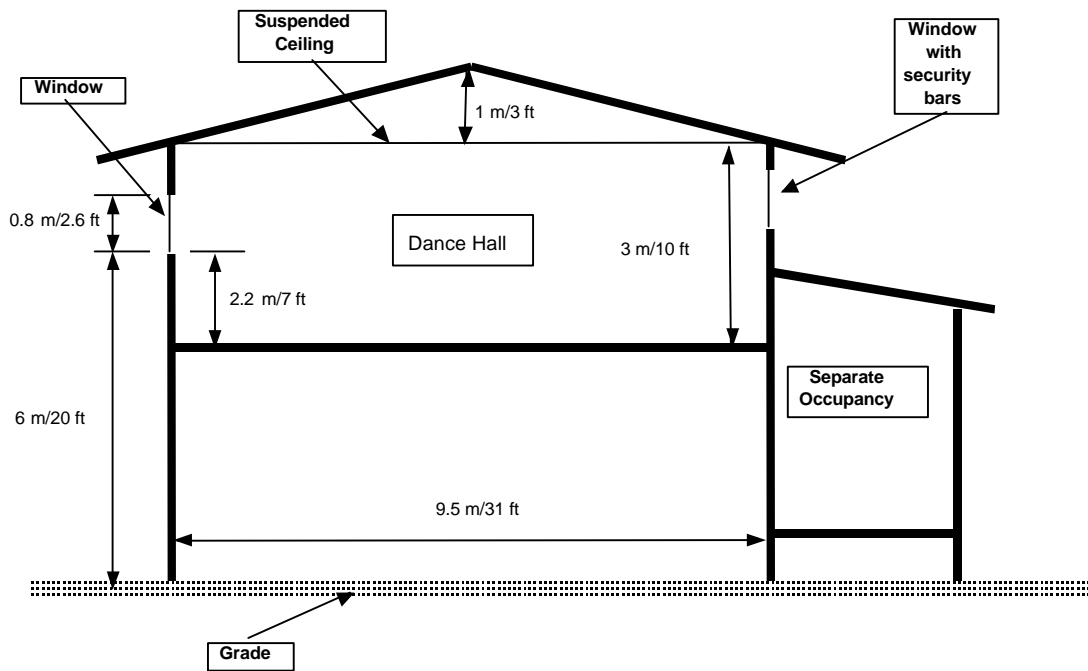
Cross Section A-A (see Figure 5)

The interior walls for these rooms were comprised of wood studs covered with gypsum board on each side. The walls extended upward for a height of approximately 3 m. The remainder of the wall, from the top of the wood stud/gypsum wallboard assembly to the underside of the suspended ceiling was comprised of glass panels. (See Figure 3)

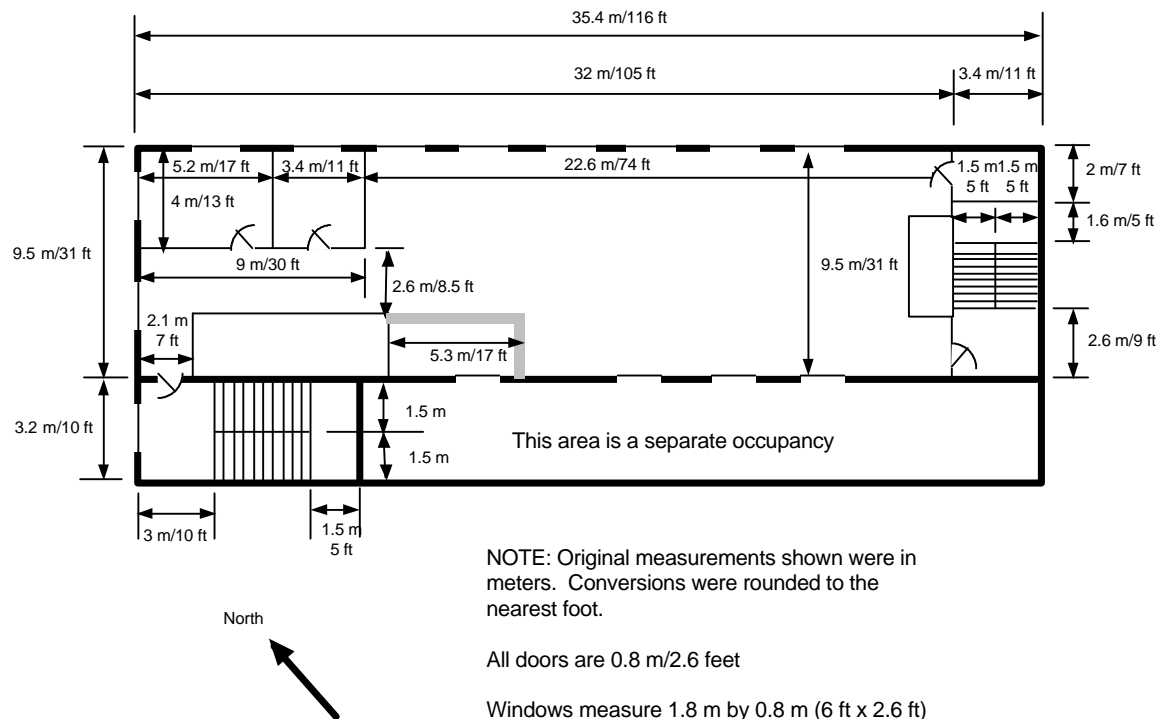
Figure No. 4 – Floor Plan of Building

The total net area of the second floor that made up the main assembly area, when deducting the ancillary rooms, closets, kitchen and serving area was 237 m² (2,551 ft²). (See Figure 4)

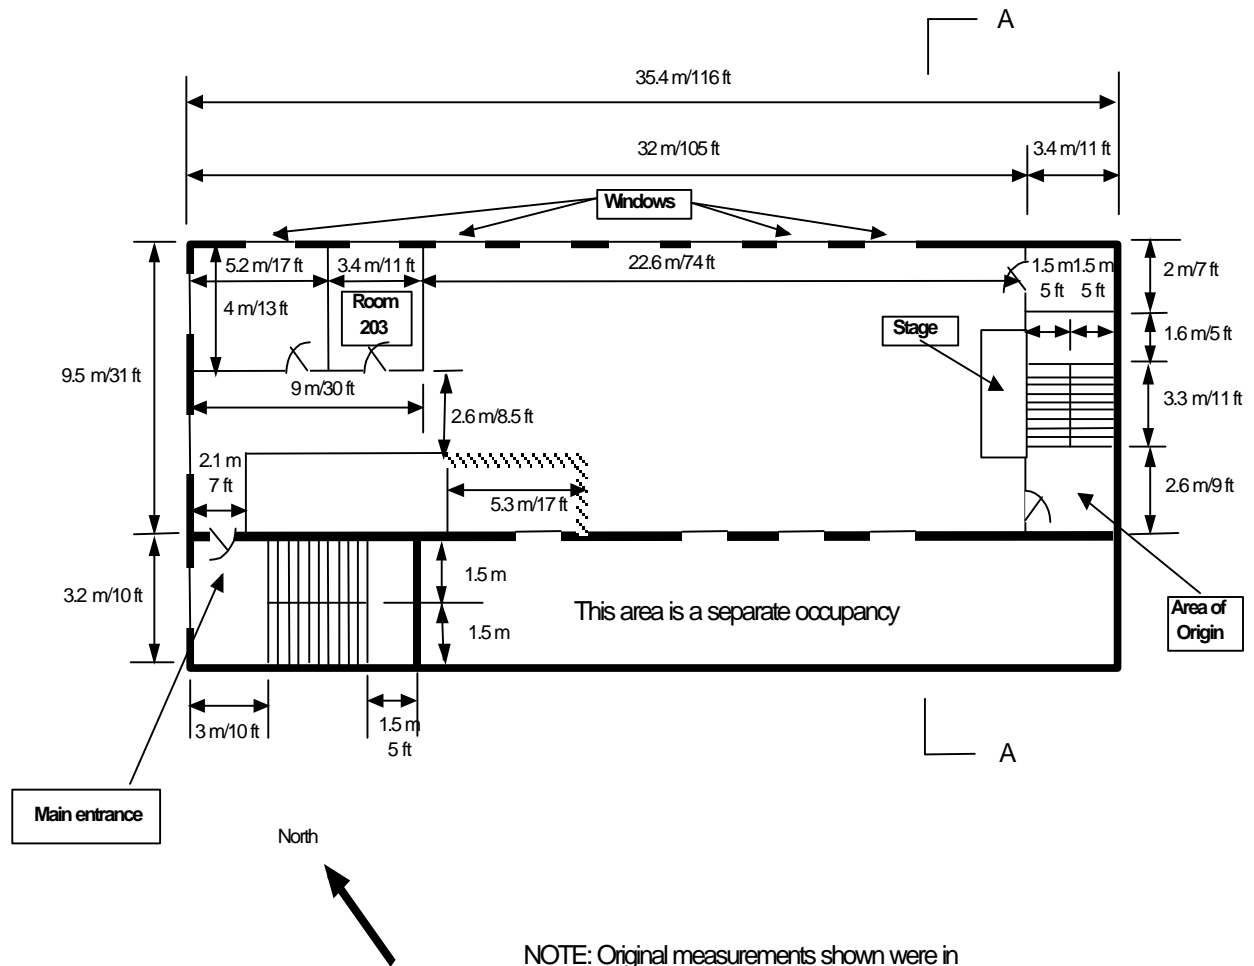
Figure No. 5 – Detailed Floor Plan

Once they were on the first floor, occupants would have then been required to traverse a path that measured approximately 100 m (328 ft) before reaching a door that discharged to the exterior. According to personnel from the fire brigade, this corridor had a one-hour fire rating. This corridor eventually widened sufficiently so that vehicles could enter it to make deliveries and pickups. (See Photo 5 and Figure 5)

All doors are 0.8 m/2.6 feet

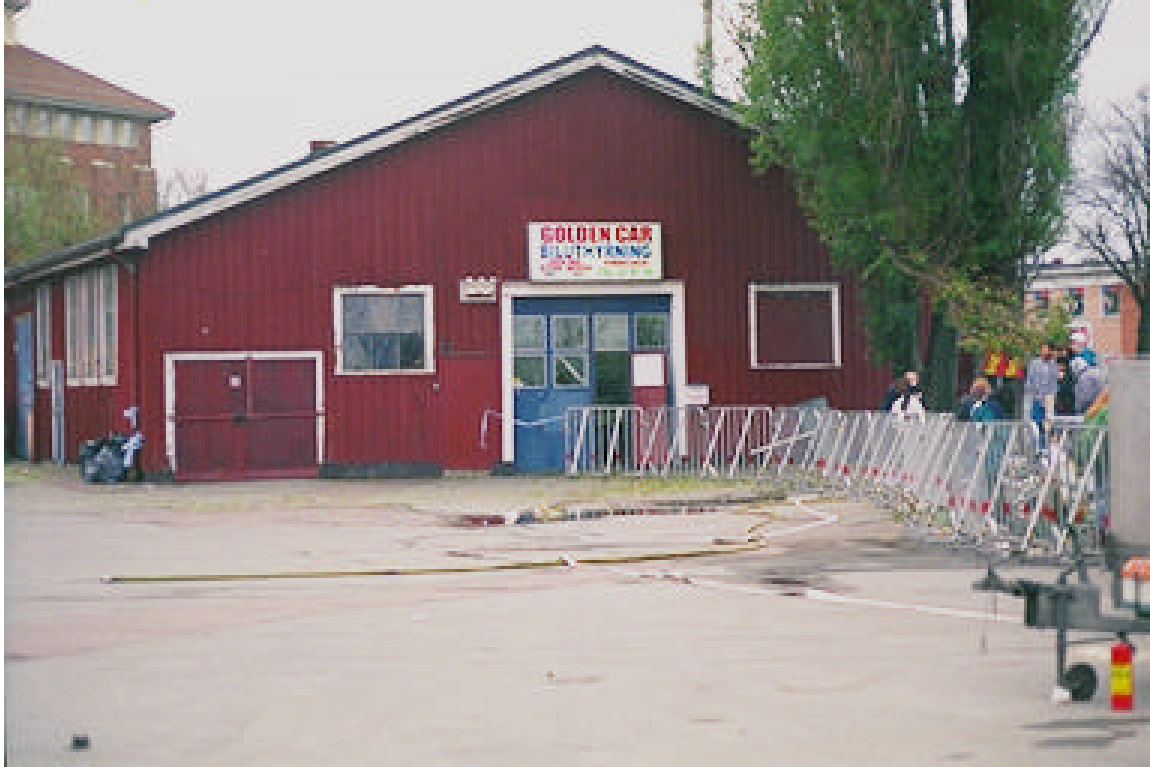
An automotive repair garage adjacent to the building was forced open and used as a triage area for the injured. A liaison with the four local hospitals coordinated the transportation of the injured based on the severity of their injuries. A doctor who was on her way home stopped to assist. (See Photo 8)

Photo No. 8 – This adjacent garage was forced open and used as a triage center for the injured victims. (NFPA)
